**Independent Investigation Report**

**The Baltimore City Fire Department  
Live Fire Training Exercise  
145 South Calverton Road  
February 9, 2007**

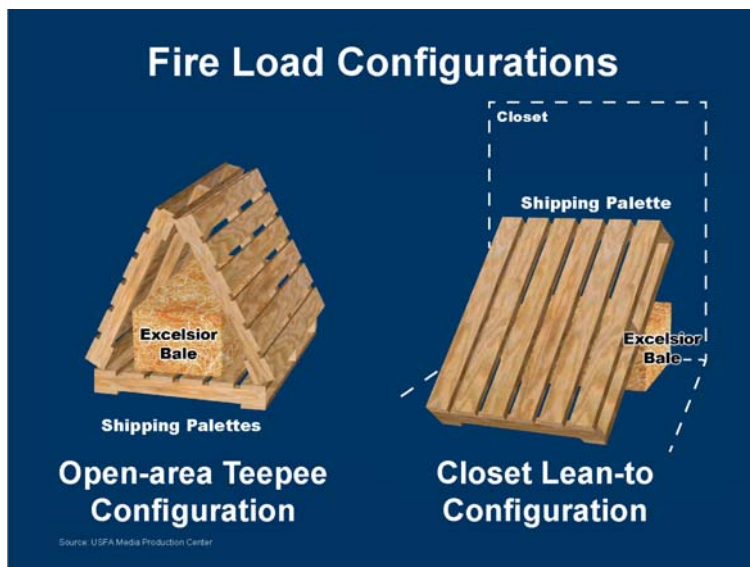
Division Chief Hyde noted in the documentation provided (Appendix B) that eleven bales of excelsior and ten pallets were used for the exercise. However, the presence of one of each fire load configuration in each of the larger rooms suggests at least twelve pallets were utilized in the set fires. These materials were distributed in various rooms throughout the structure by recruits and eventually were ignited. According to those involved with distributing the materials and setting the fires, two load configurations were used in each of the larger rooms. In one configuration, a pallet was laid flat on the floor as a base, with two others angled on the base, to form a “teepee” type construction. Excelsior was placed within the open area of the configuration. Another configuration used was the leaning of a single pallet against a wall, then placing excelsior between the pallet and the wall (Shown below).

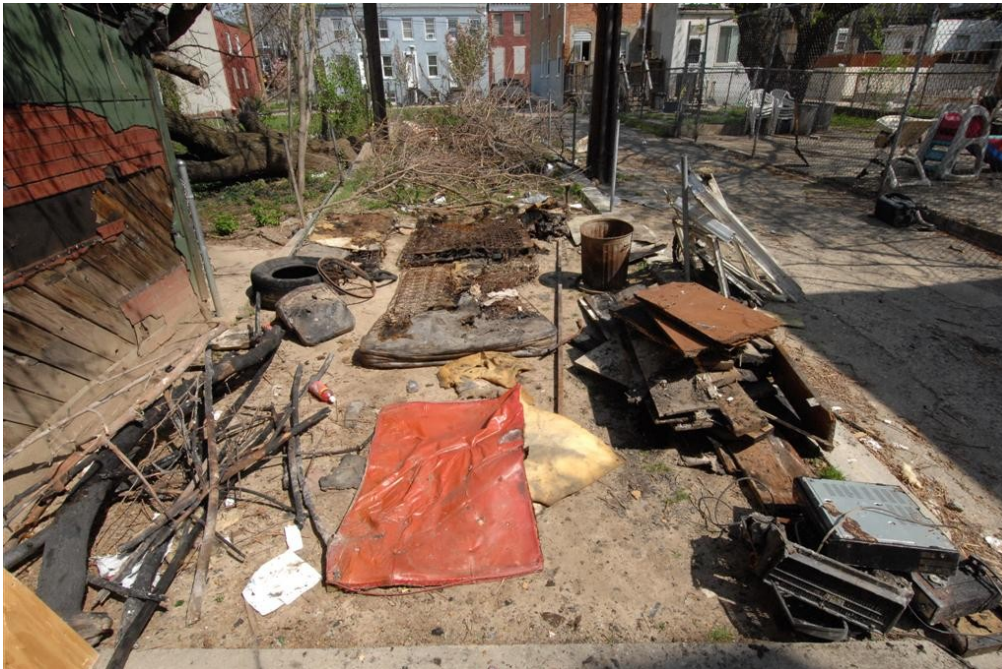
The picture below shows the debris that was removed from the first floor rear room

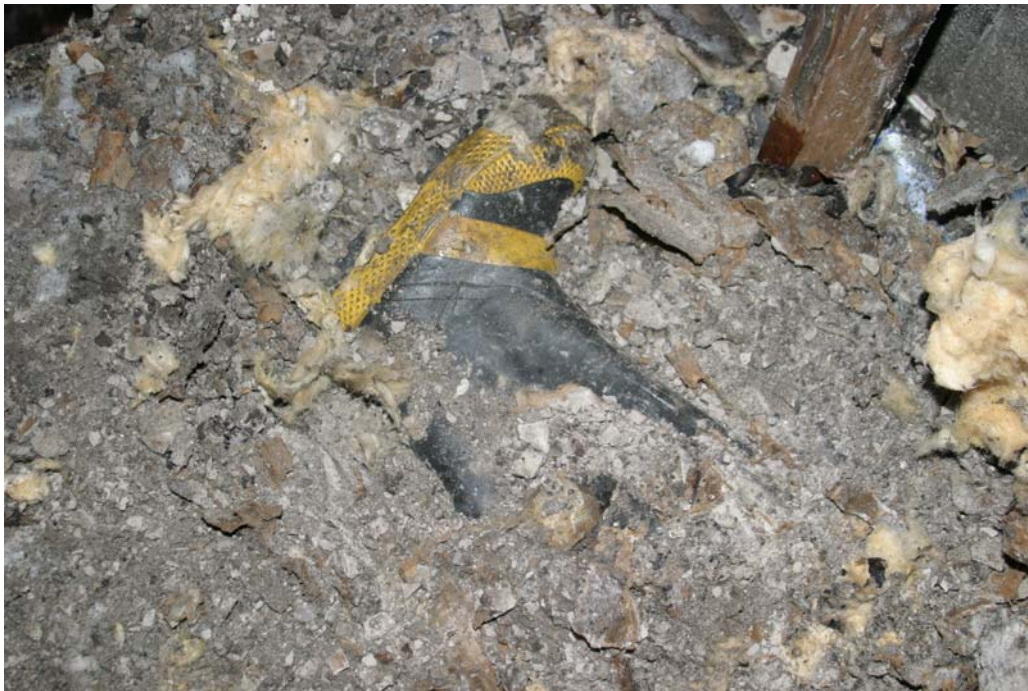
Baltimore City Fire Investigators determined that the left boot worn by FPA Racheal Wilson on February 9, 2007, was missing and was believed to have remained at the site. Accordingly, Lieutenant Rubeling, Captain Martin, Captain Lehl and Chief Bull returned to 145 South Calverton Road on February 20, 2007, to conduct a search for a missing boot. After examining the frozen debris on the third floor landing near the rear window, the boot was recovered.

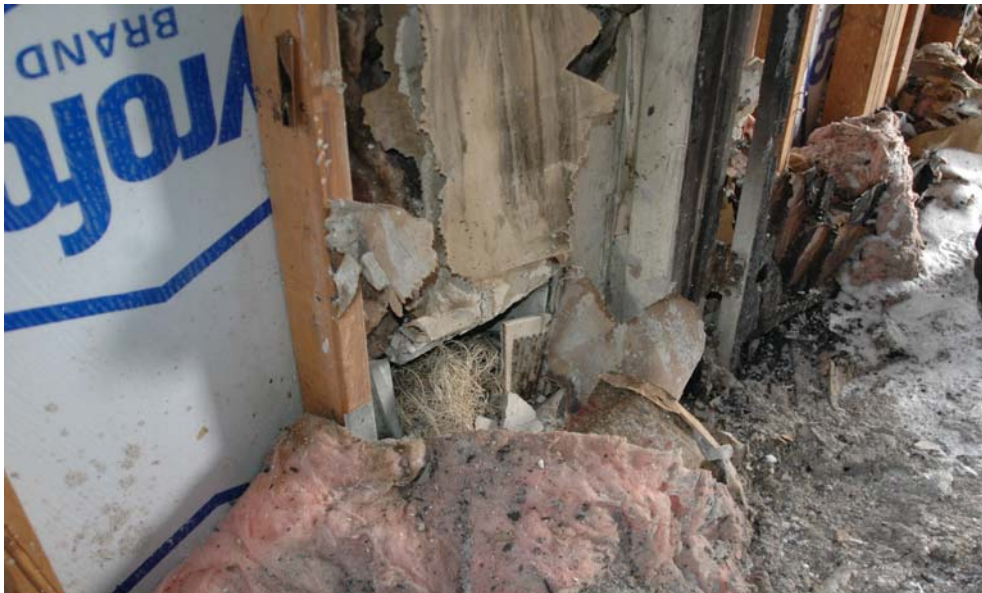
**Discussion:** It was reported that excelsior (additional fuel load) had been stuffed between the joists where the ceiling once was. In addition, Lieutenant Crest stated that they pulled wallboard and stuffed excelsior behind the walls. A walk through of the building by the investigative team revealed the excelsior in the exposed ceiling had ignited and was almost entirely consumed by fire, but that which was placed behind the walls did not fully ignite (See Photo). Contrary to the intent of the standard that the interior walls and ceilings be intact to avoid unsafe fire extension, Academy instructors participated in and directed students to load the void spaces created by the ventilation drill with combustible excelsior in an attempt to intensify the conditions to which recruits would be exposed.

Excelsior fire loading in vents between wall studs.

**Recommendation:** Patch all holes in the ceilings and walls as specified by the standard.

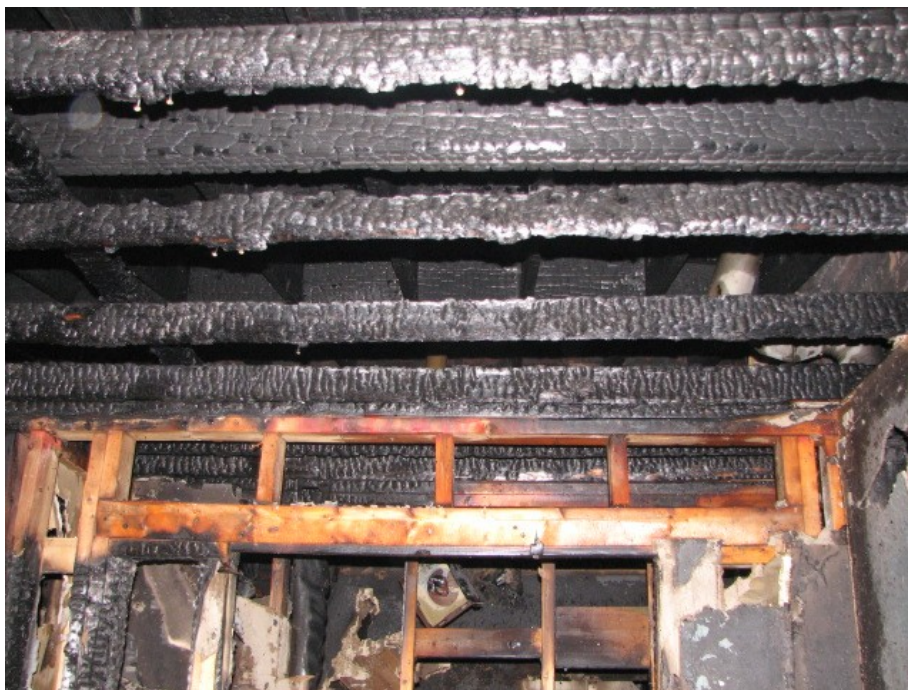
The exposed ceilings appear to have been a major contributing factor to the incident. This structural condition and other factors, such as the open ventilation of the structure combined with the placing of excelsior between the joists, likely contributed to the rapid fire spread and build up of heat that caused deteriorating conditions (See Photo). A fire set in the rear room of the second floor rapidly spread to a void space between the open ceiling joint and the roof and traversed under the roof toward the stairway and the area on the third floor where EVD Ryan Wenger, Paramedic Cisneros, and FPA Wilson were positioned, exposing them to intense heat and limited visibility. A ceiling that was intact would have slowed the rapid spread of fire and heat from at least four fuel load configurations set under the second floor roof.

Second floor rear room showing extensive char to ceiling joist under second floor roof.

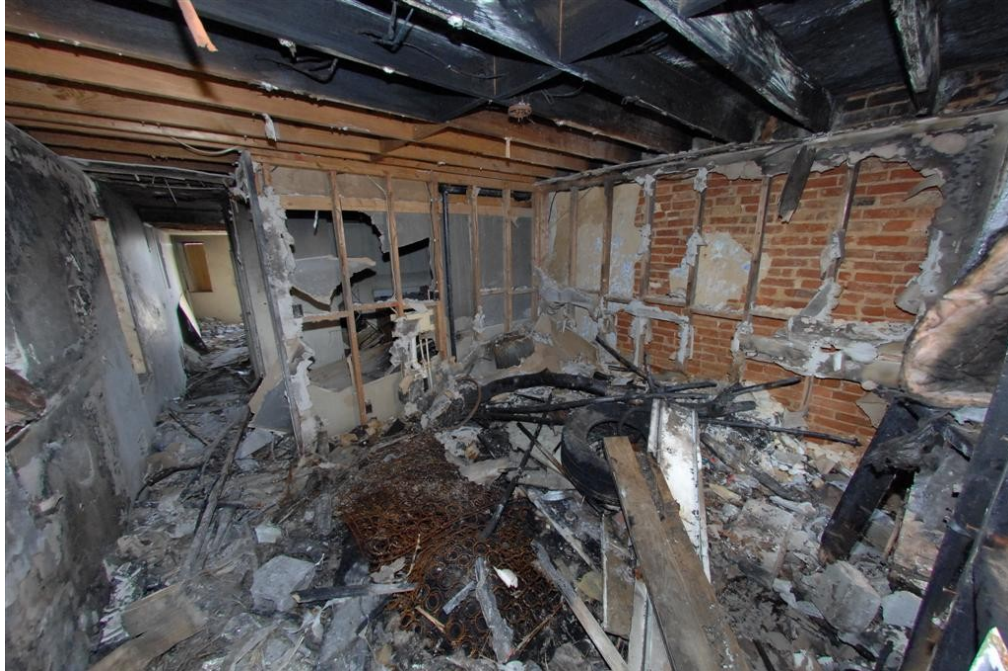
Debris in rear room prior to removal.

Both the obstructive and combustible debris created and contributed to an unsafe condition for personnel as they participated in the training exercise. As was mentioned previously, the crew of Engine 1 was instructed to proceed directly to the third floor. Wenger allegedly confirmed those instructions with Crest. The reason Crest supposedly told them to go directly to the third floor

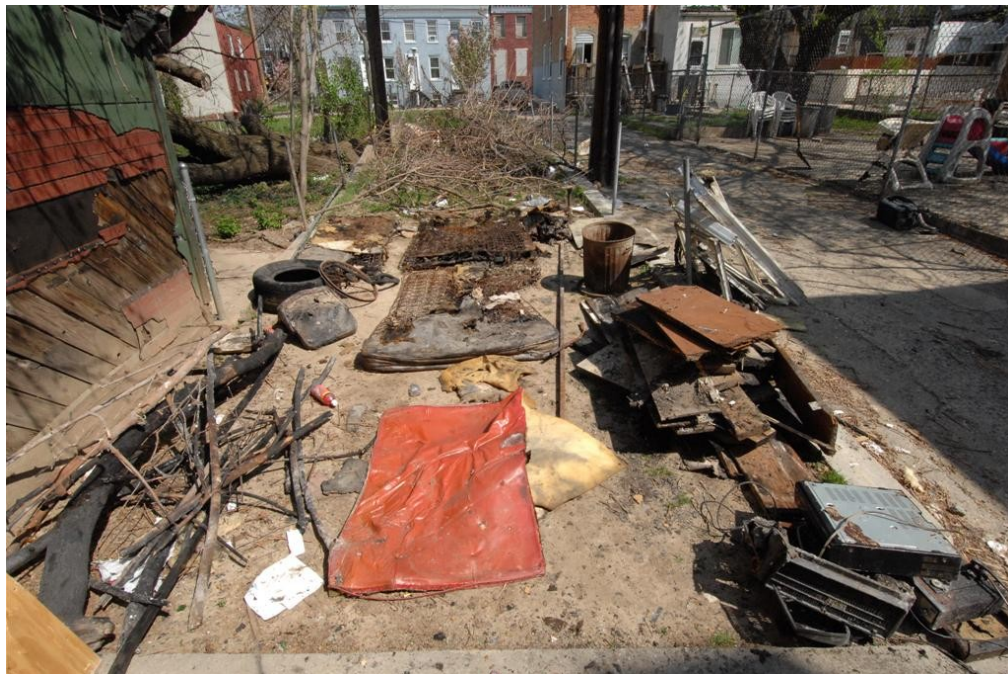
Debris on concrete pad after removal from rear room.

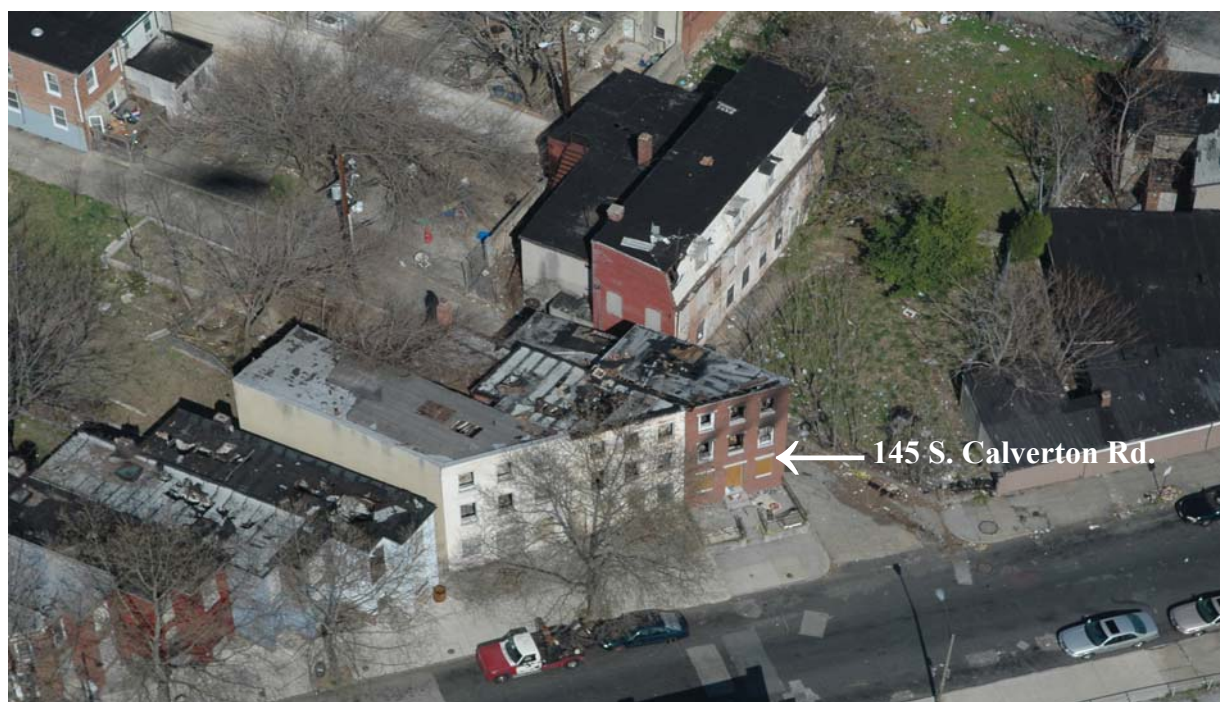
Picture shows exposures to B and D sides of structure.

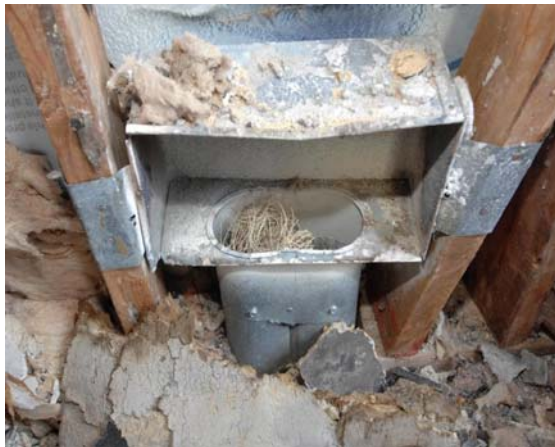
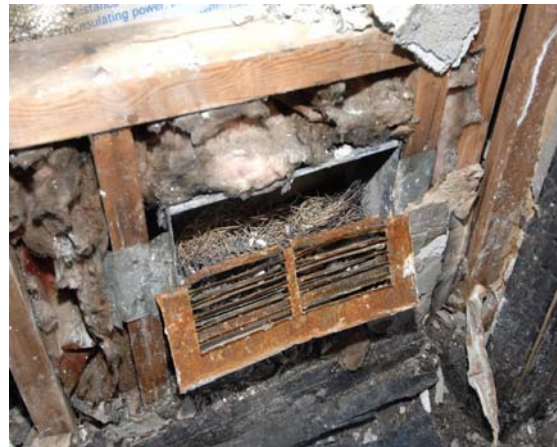
Eleven bales of excelsior, when separated, creates a large amount of surface area that can ignite and burn rapidly. It was mentioned that excelsior was placed in the open spaces of the ceilings and stuffed behind the sheetrock in the walls. In addition, unburned excelsior was found in the heat vents throughout the structure.

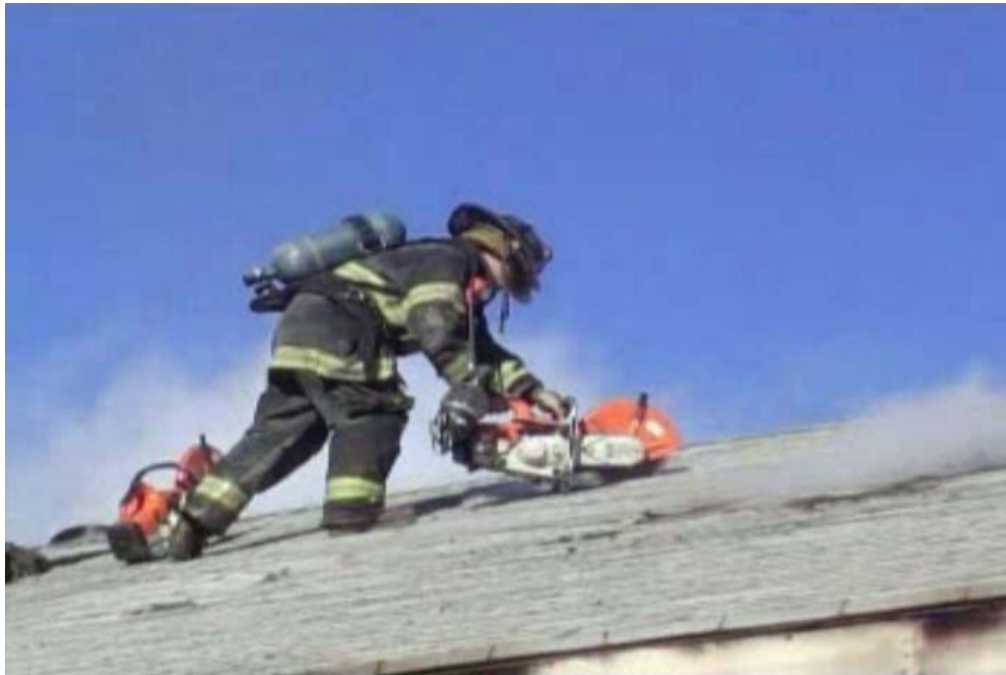
Unidentified adjunct instructor working on the roof without gloves or SCBA in-place.

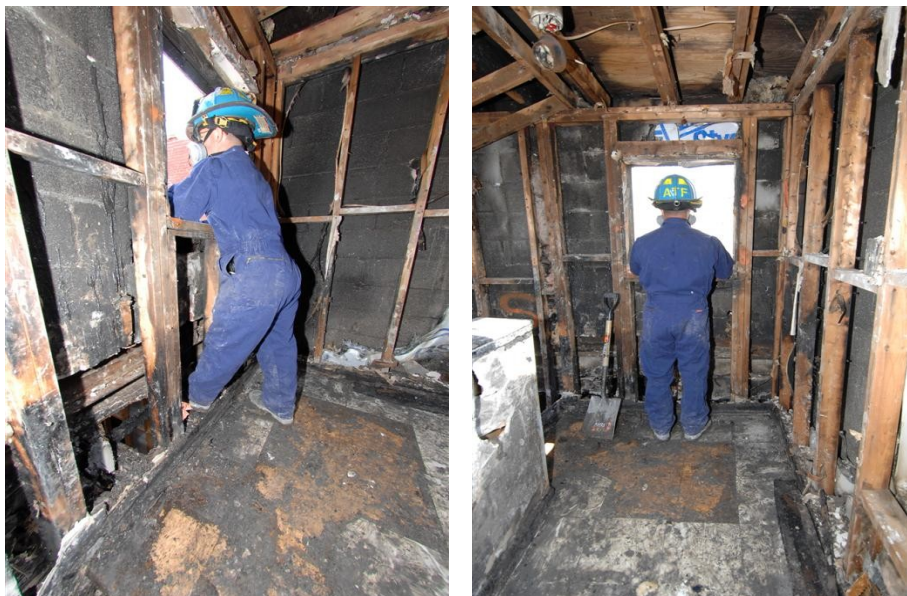
Although not currently a code violation, the level of the window sill through which Wenger, Cisneros, Wilson, and Tina Strawsburg exited was unusually high, measuring 41 inches from the floor. Given Wilson's height of 64 inches, this would have placed the level of the sill at approximately the middle of her torso. One of the members of the investigative team is five feet, six inches tall. He is shown in the photo below at the window where Wilson was rescued. The photo is an approximation as to the height of window sill in relation to Wilson. Wenger stated in his interview with BCFD investigators that he had to pull himself up a bit to get out of the window. One of the members of the investigative team who interviewed him during the NIOSH interviews stated that he appeared to be at least six feet tall.

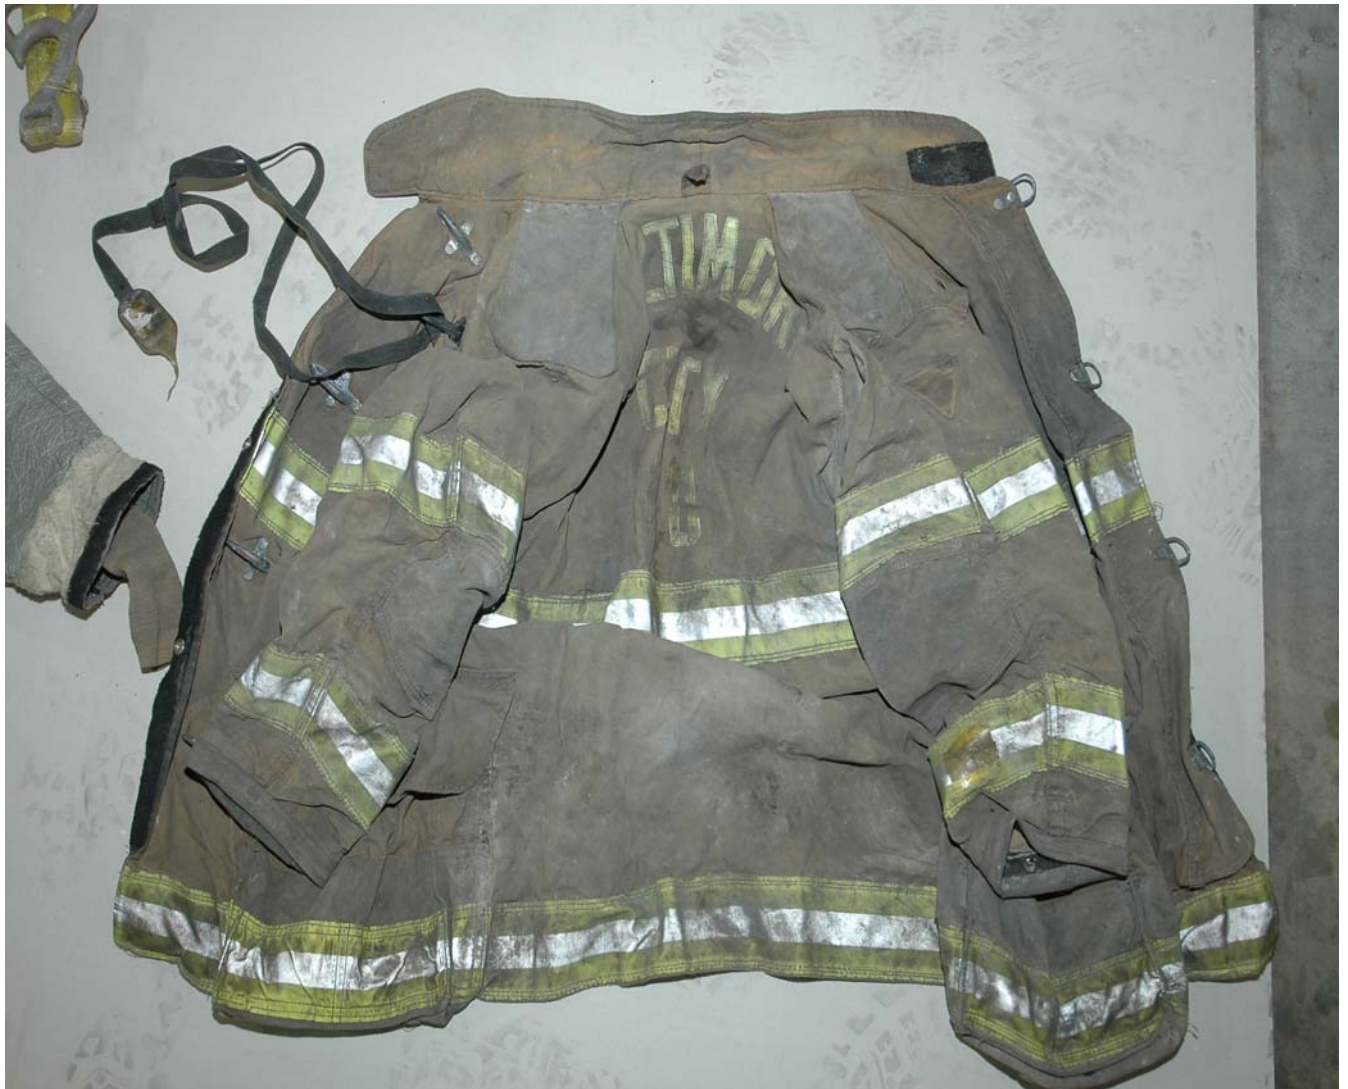
The coat was noted to be in serviceable condition, but nearing the end of its useful life. Interesting was the fact that the report stated the coat suffered little thermal exposure. Given the severity of Racheal Wilson's burns on her torso and arms, one would have thought that the coat would have shown signs of exposure to heat.

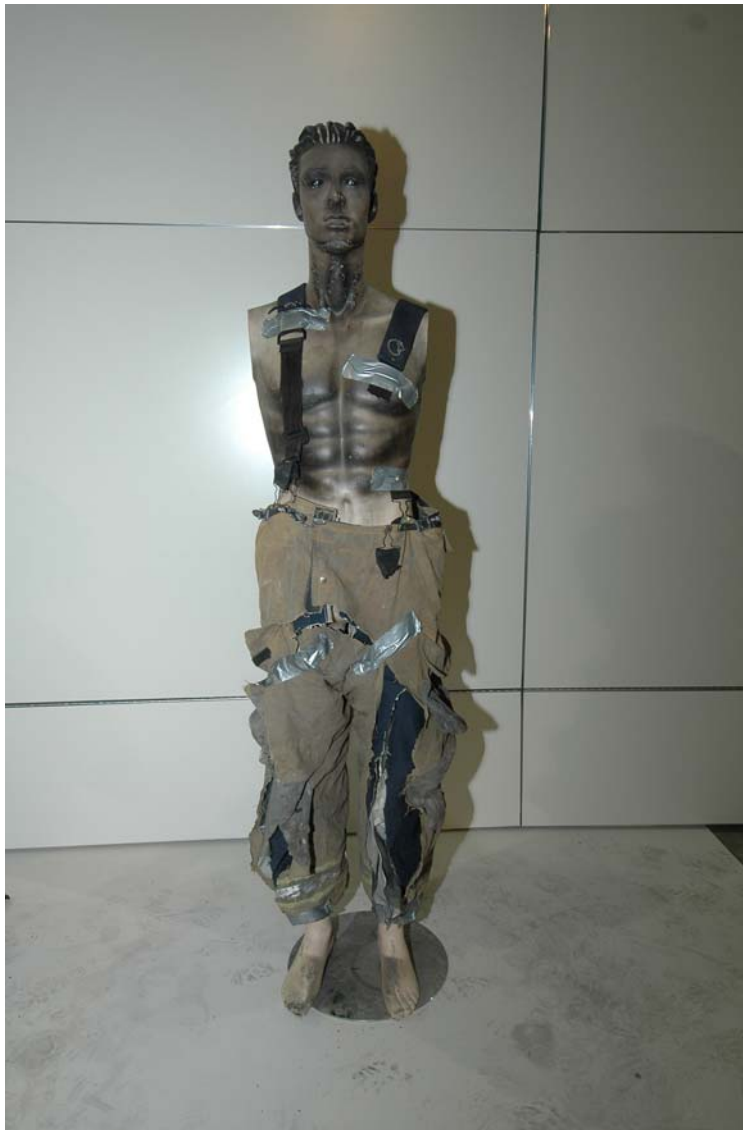
The pants, which were manufactured in 1997, had significant problems. Many areas were noted to have been patched or repaired. The leather on the right knee was worn through in some places and there was a “medium size hole” at the base of the fly. The report stated that the crotch seemed to have no integrity, and the thermal protection in the crotch and upper thigh was diminished, due to abrasion and wear. The pants were said to be beyond their useful life and the recommendation was that they be retired. This may have accounted for the serious burns Wilson suffered to her lower extremities.

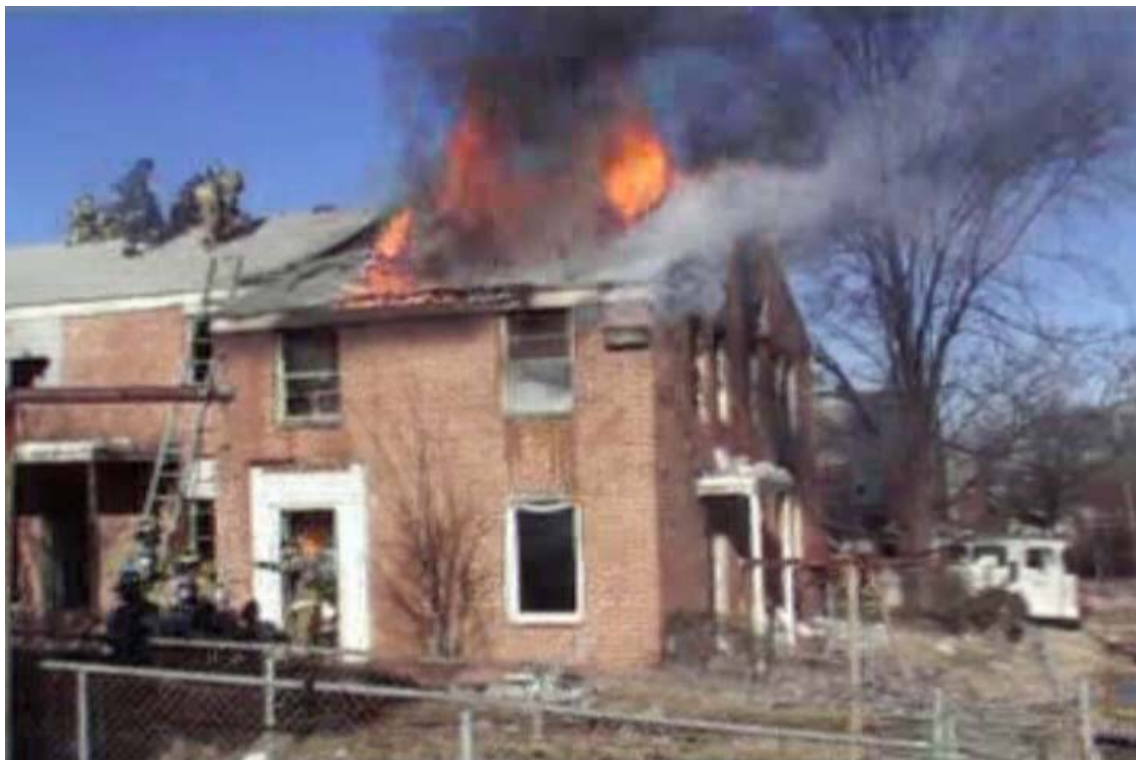
Photo (B) showing intensity of fire. Fire evident on the neck of recruit at doorway.

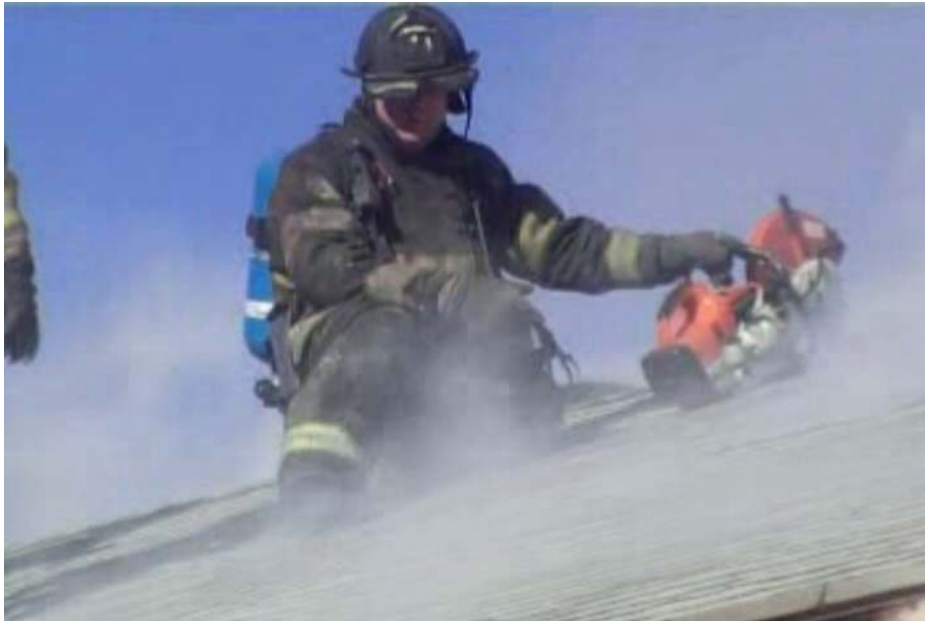
An instructor on roof without breathing apparatus.

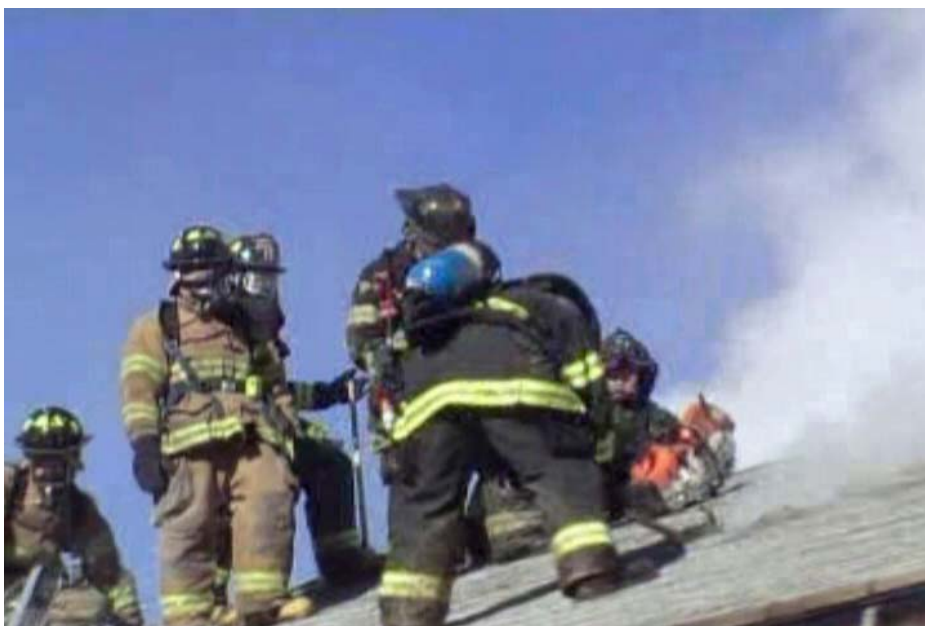
An instructor on roof without breathing apparatus; recruits on roof with breathing apparatus.

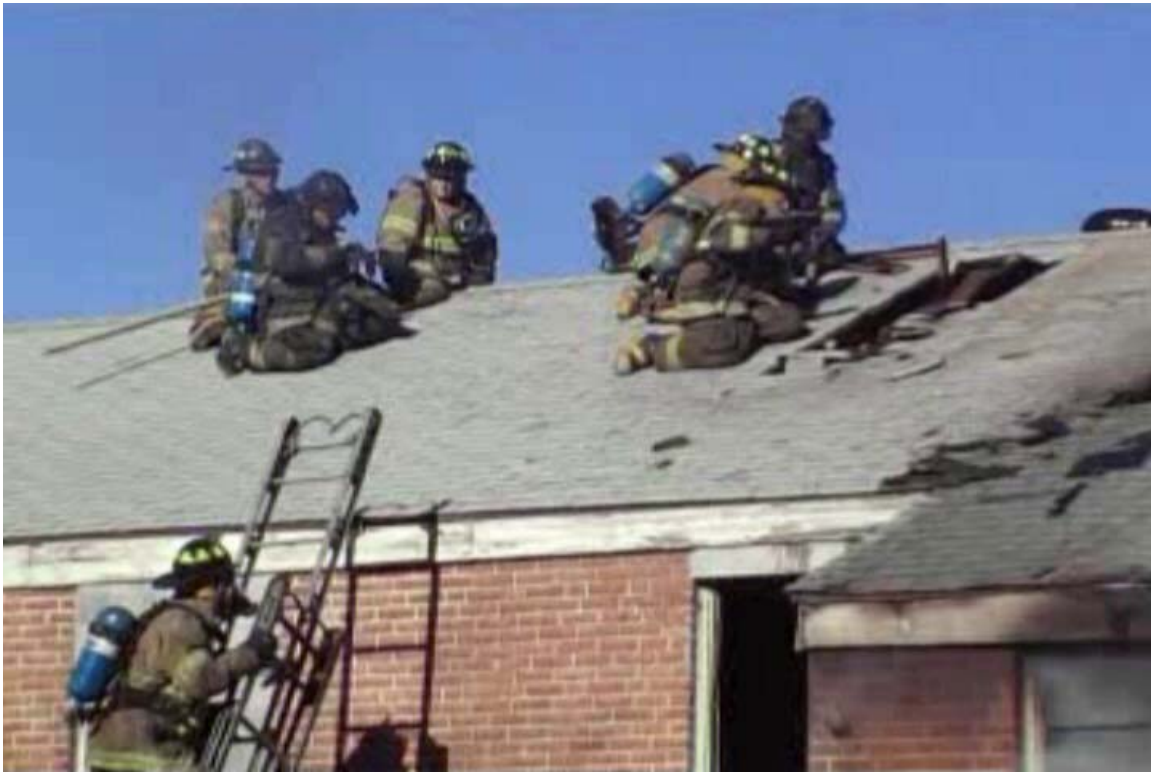
Recruits on roof without breathing apparatus.
