**Independent Investigation Report**

**The Baltimore City Fire Department  
Live Fire Training Exercise  
145 South Calverton Road  
February 9, 2007**

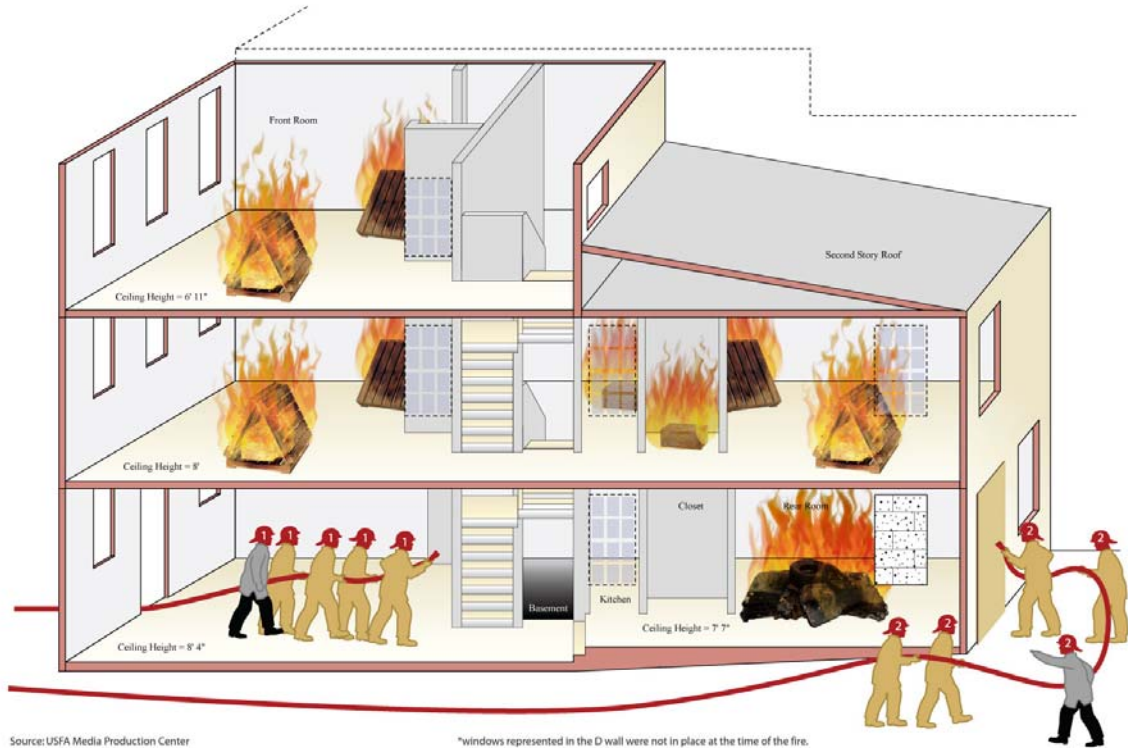
**Figure 1**

Engine 1 entering structure, Engine 2 preparing to enter the rear.

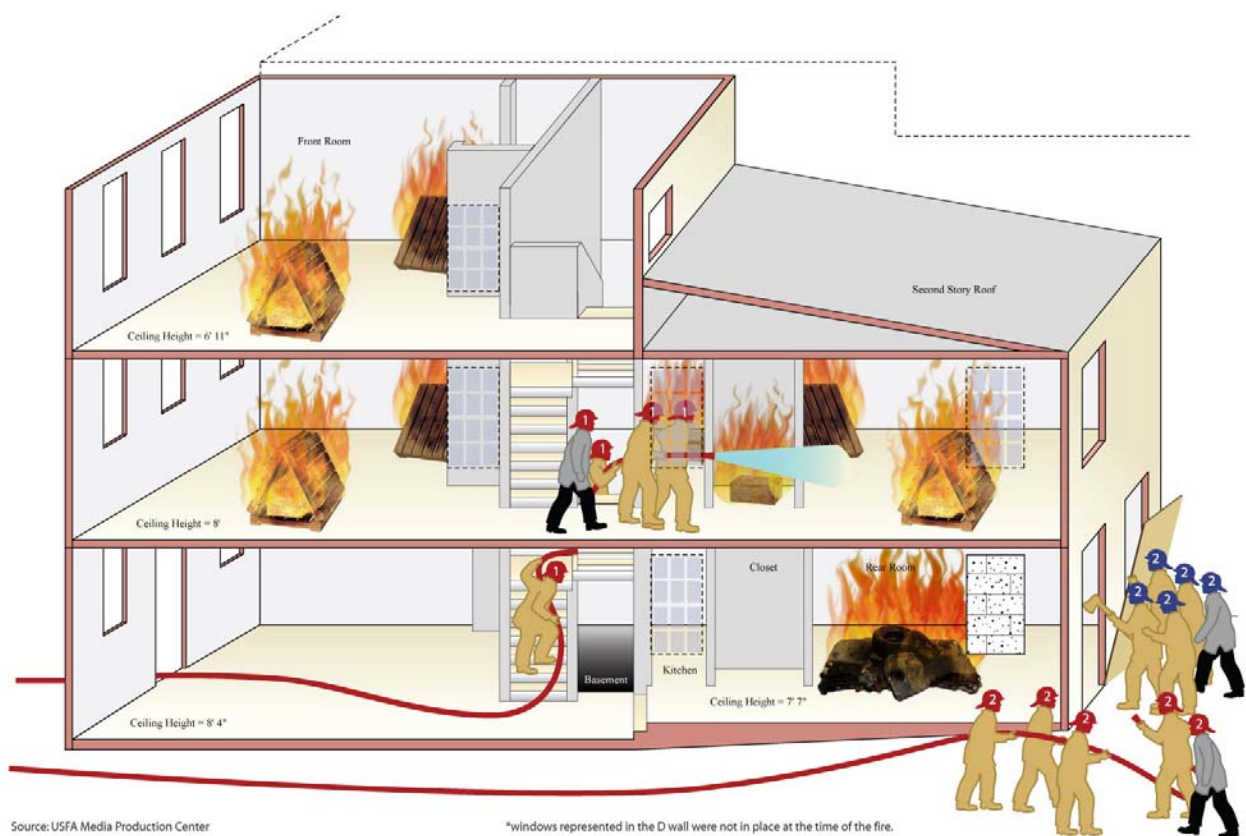
**Figure 2**  
Engine 1 on 2nd floor, Truck 2 opening the rear.

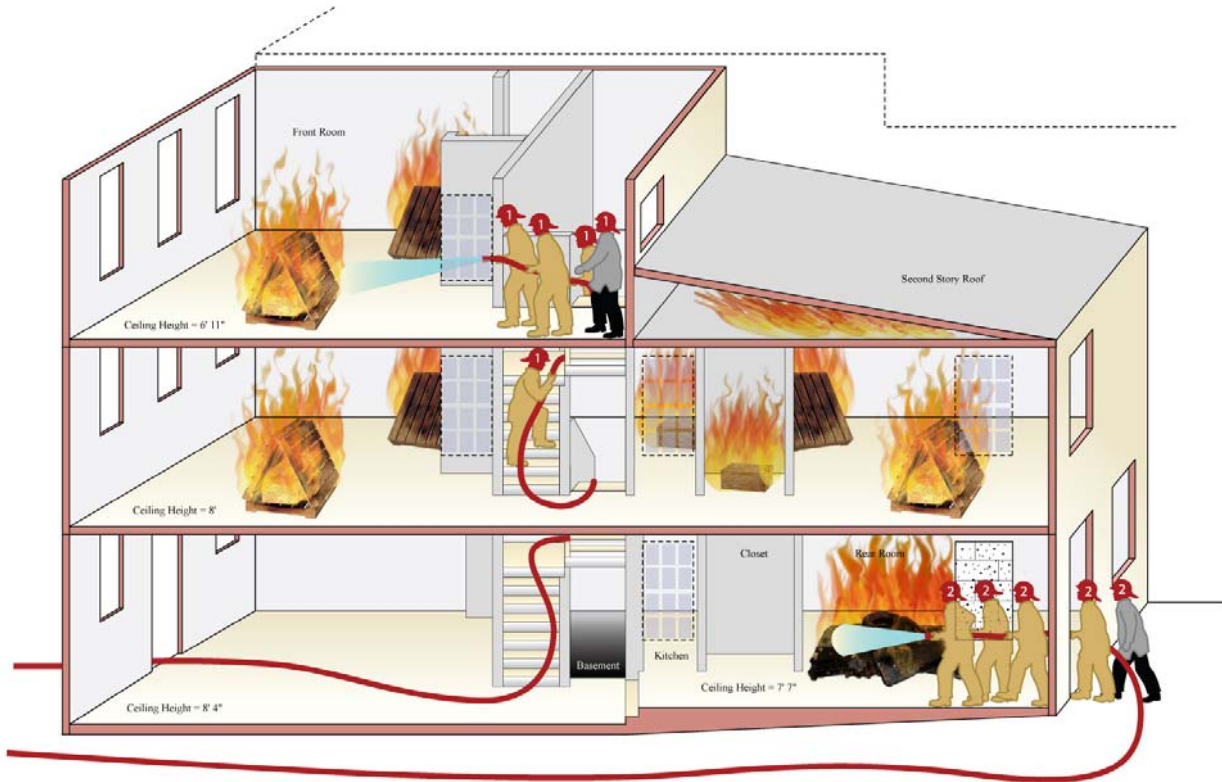
**Figure 3**

At this point Engine 2 entered the rear of the structure and encountered a rubbish fire in the back room that was not discussed during the briefing (Figure 3). Wenger stated that the heat at the third floor landing was intense, so he leaned out the window in an effort to gain an understanding of the fire conditions. Without a radio, he had no means to communicate his observations or circumstances with the Incident Commander or receive further instructions.

Engine 1 on 3rd floor, Engine 2 attacking fire 1st floor rear.

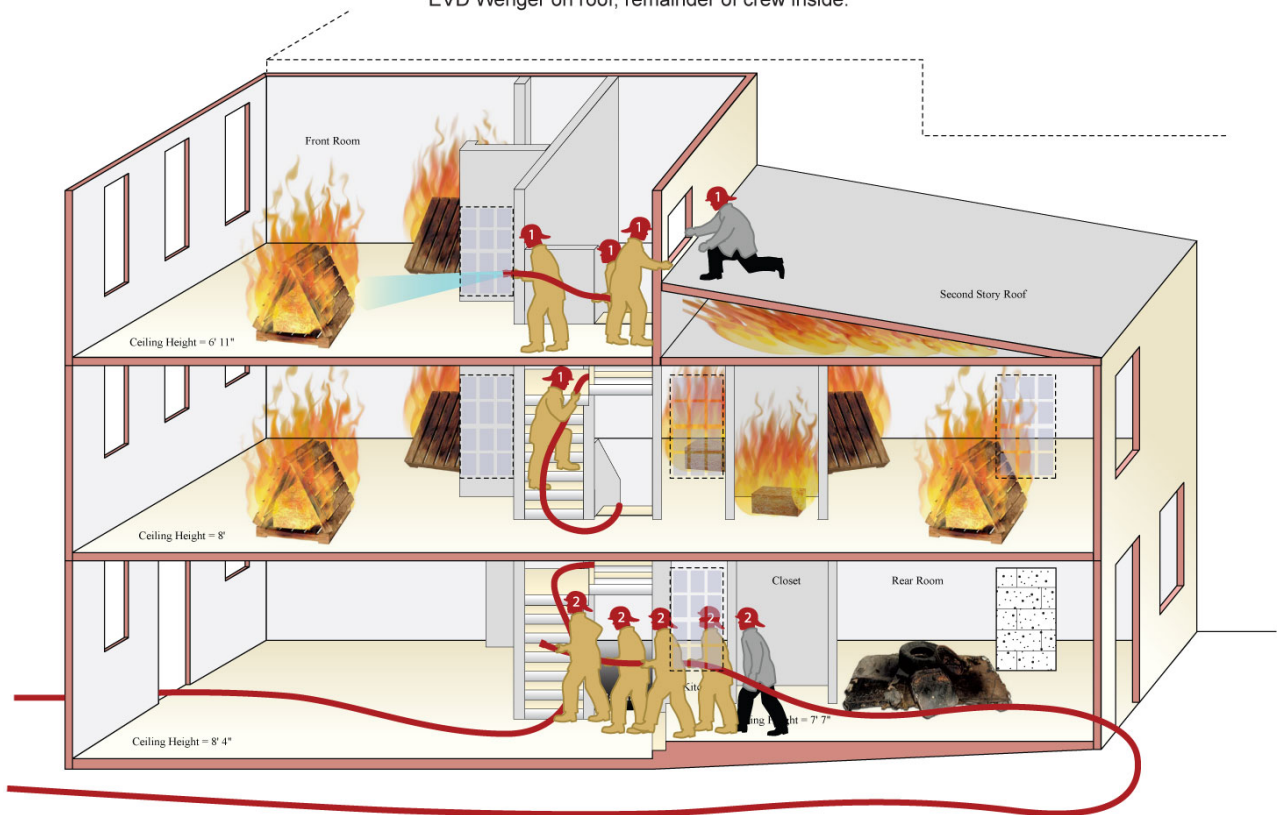
**Figure 4**

Engine 1 personnel on 3rd floor and Engine 2 advancing to 2nd floor.  
EVD Wenger on roof, remainder of crew inside.

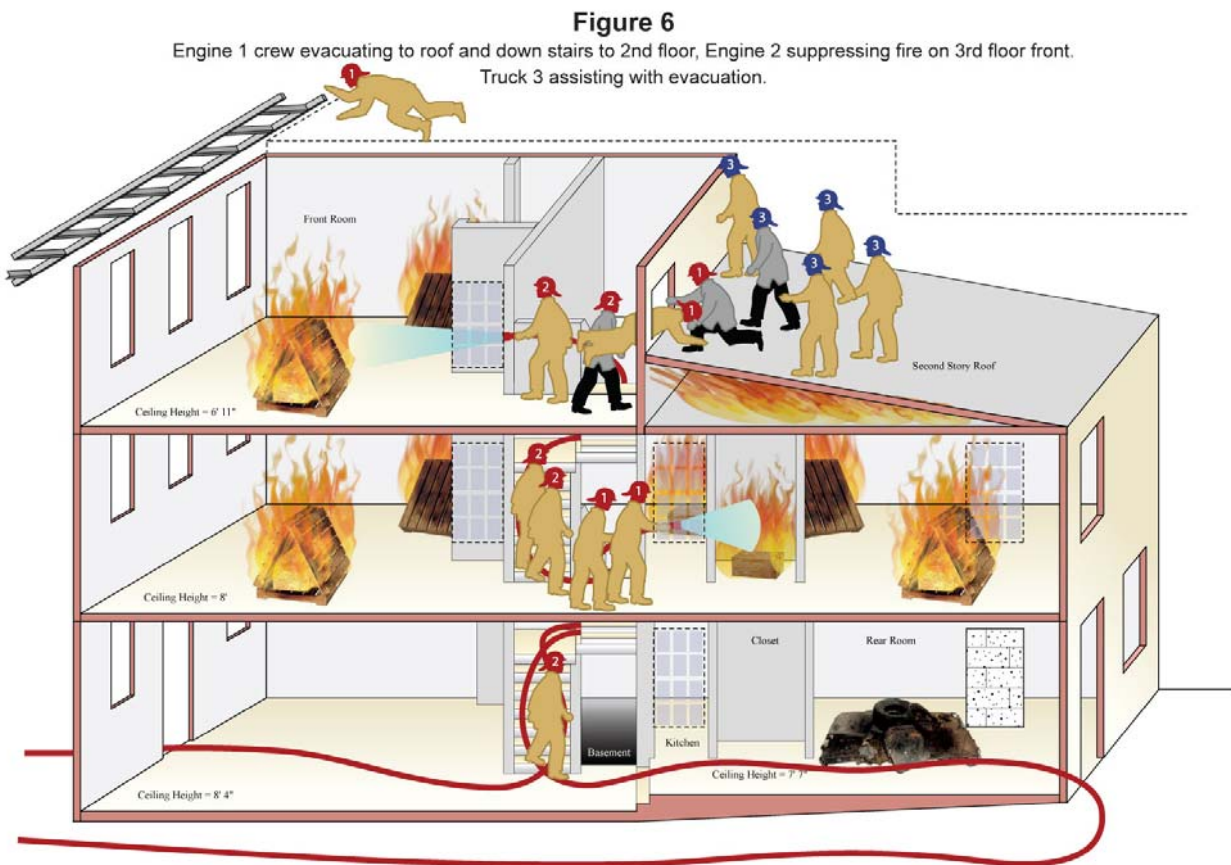
Hiebler and Robinson then tried to assist Wenger by grabbing Wilson's legs and trying to push her out of the window. Hiebler, who was concerned the fire on the third floor was getting out of control, told Robinson to extinguish the fire and he would assist Wenger with Wilson's rescue (Figure 6). Hiebler lifted Wilson's legs and with the assistance of those pulling from the outside, was able to remove her from the building. Hiebler stated that once he gained control of Wilson's legs, she was removed from the building without difficulty.

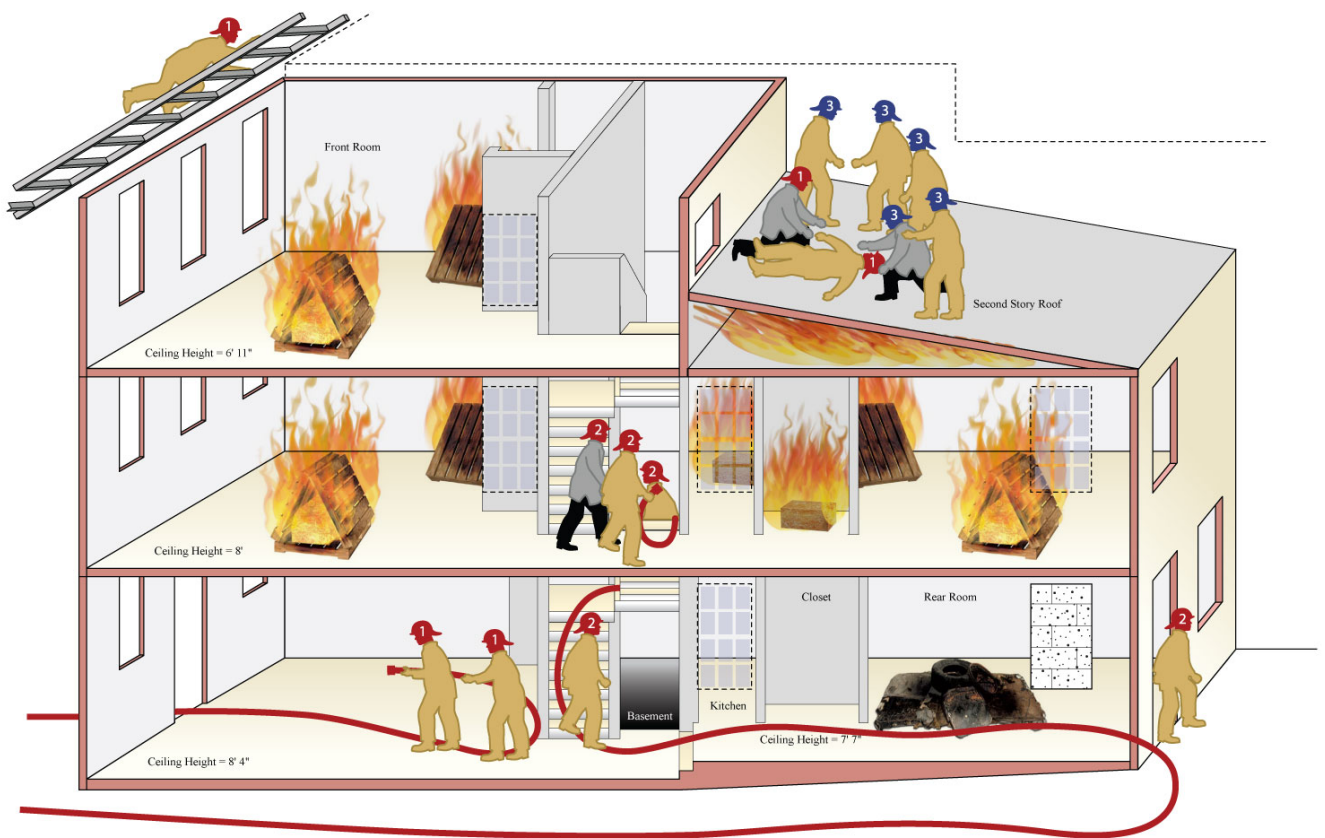
**Figure 7**

Racheal Wilson rescued, CPR initiated. Other crews evacuating structures.

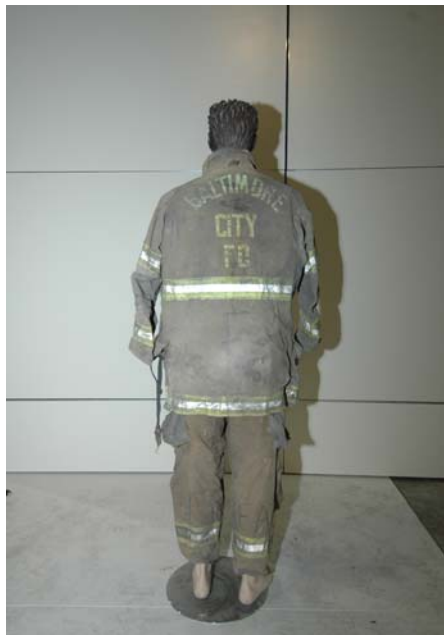
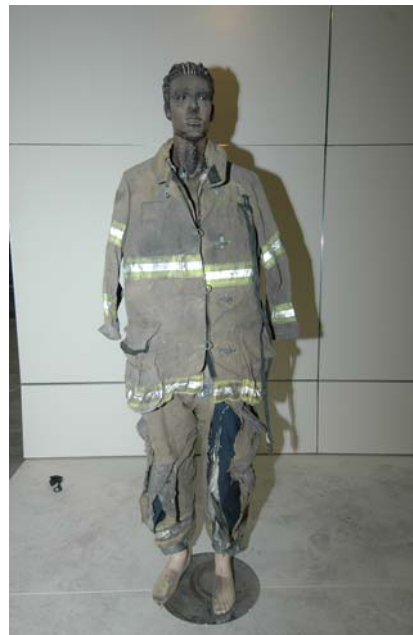
Chief William Jones. The items were fully photographed in a static display, then placed onto a mannequin to portray the manner in which the garments were actually worn by FPA Wilson.

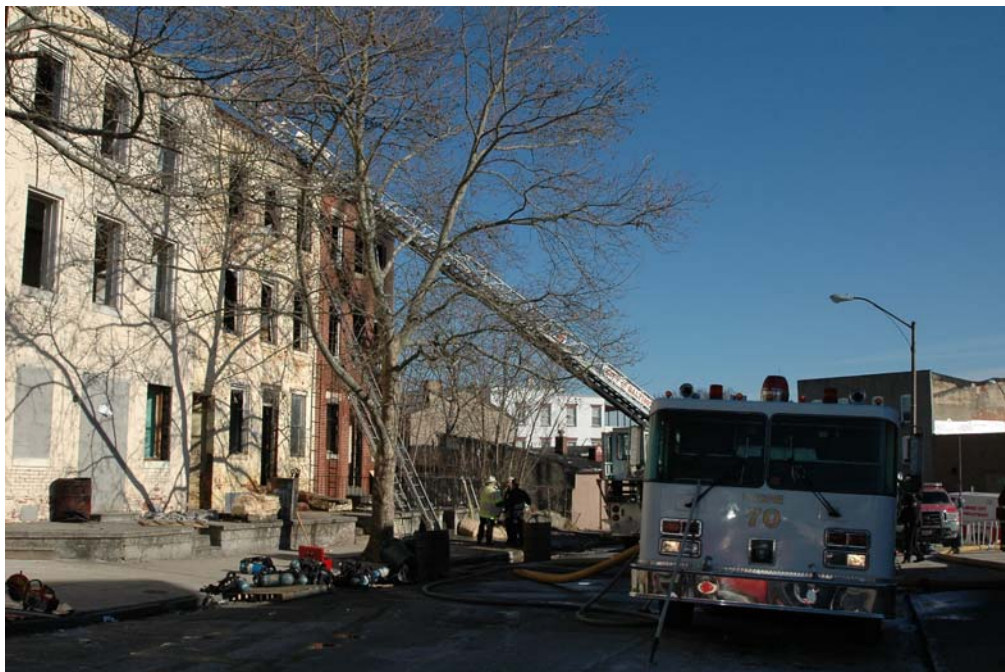
**Finding:** There is no evidence that an effort was made or a plan was in place to protect any exposed structures.

**Discussion:** The dwelling used was the end unit of a three unit block section that also included similar structures 143 and 141 South Calverton Road. The unit at 143 South Calverton was attached to 145 South Calverton and easily could have been involved as well. In addition, there is a structure across a ten foot alley that also could have been considered an exposure.

141, 143, and 145 South Calverton Road.

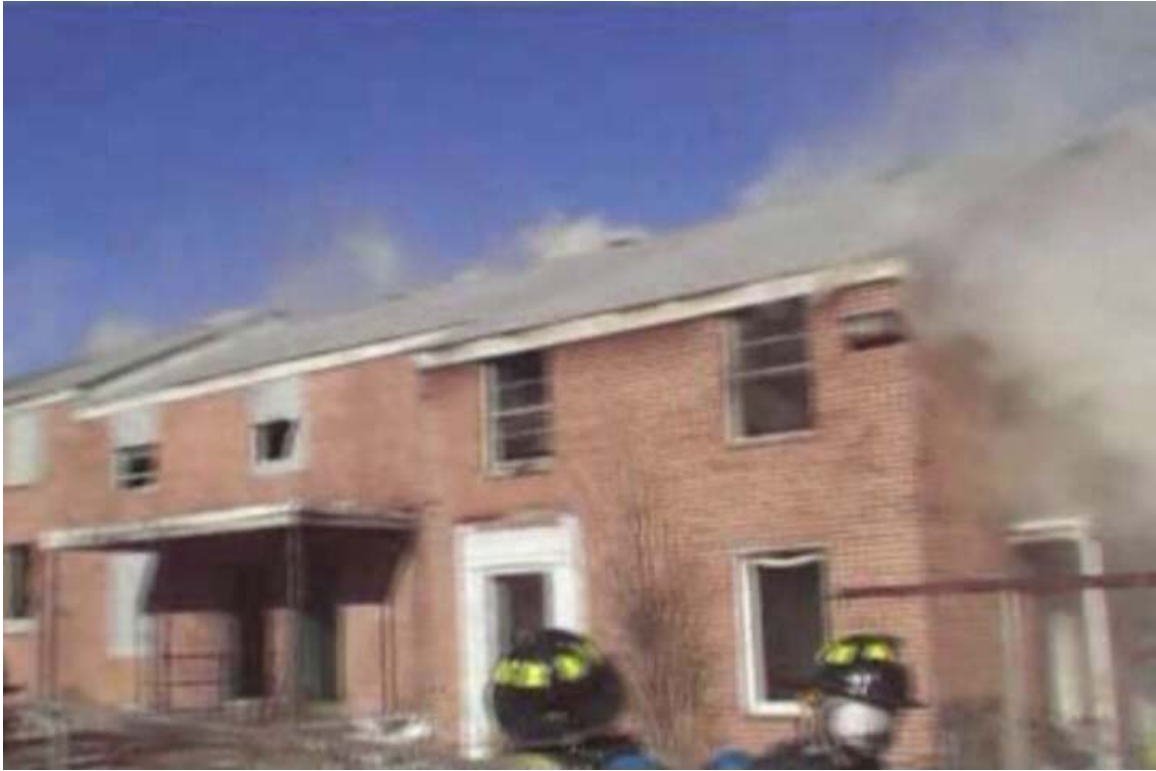
The video shows the fire as it progressed. It is fairly obvious from the video that the required compliance with NFPA 1403 did not occur at this training exercise either. Although the number of fires that were present in the building cannot be determined, it appears as though there was more than one. The intensity of the fire was of concern as well, as the second floor of the structure was well involved (See Photo B). Fire also appeared to extend beyond the building in which the recruits were training, as smoke was visible in at least two of the adjoining buildings (See Photo A). A voice on the video can be heard saying "Give it up, it's what I want to do". At one point, two recruits were observed exiting the structure. Fire could be seen burning on the back of the second recruit's helmet and/or neck area (See Photo B). The first recruit brushed the fire away and they re-entered the building a short time later. At no time was an instructor seen with these two recruits. This fire was far too intense for this group of FPAs, given their limited training prior to February 8.

Photo (A) showing smoke spread to multiple occupancies.

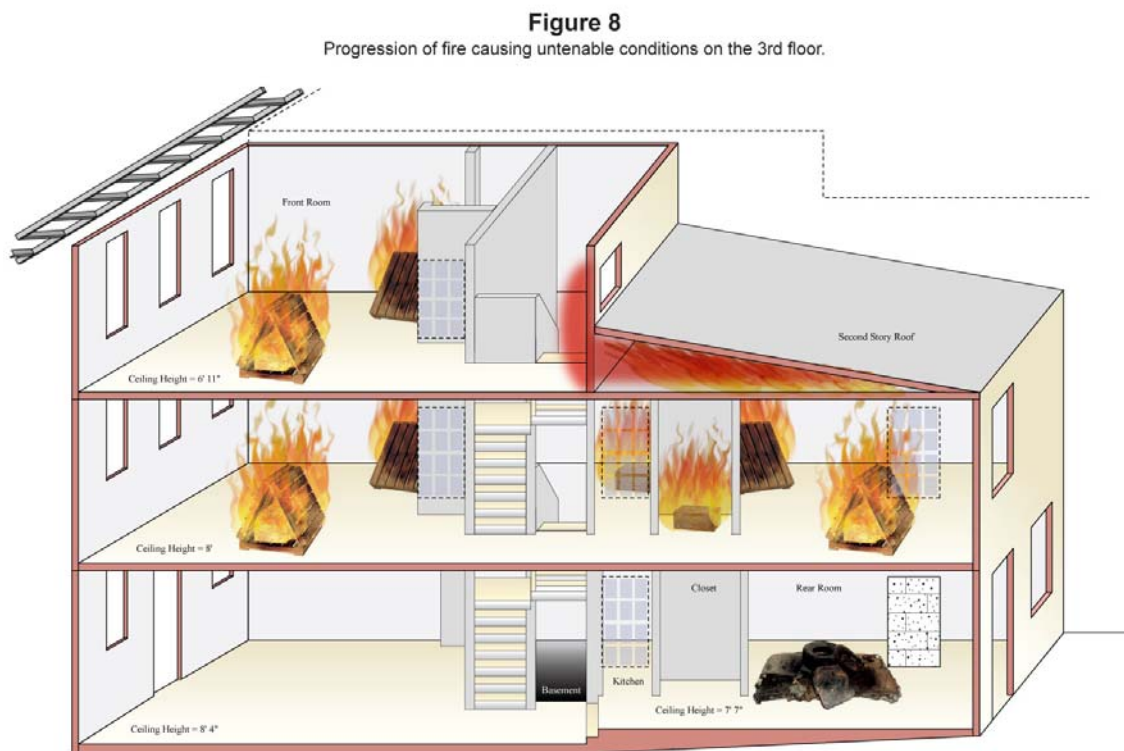
The room to the rear of the second floor was the one in which the ceiling had been pulled during previous training. This left an opening for the fire to travel with little resistance to the area under the roof that covered that portion of the second floor. The fire traversed throughout the area under the roof, causing high heat conditions in the area of the third floor where Wenger, Wilson, and Cisneros were located. In addition, heat and flame from other fires on the second floor proceeded up the stairs to the same area on the third floor. Finally, the fire on the third floor added to the untenable conditions the crew of Engine 1 encountered on the third floor.
